February 22, 1966

To All Chrysler-Plymouth Dealers

Modification of Brake Master Cylinder Auxiliary Reservoir Anchor Plate

Models Affected: 1965 and 1966 Chrysler, Plymouth Fury, Valiant, and Barracuda equipped with disc brakes.

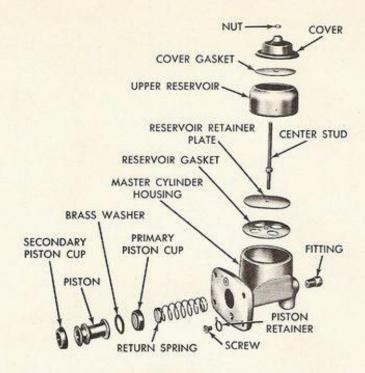
Disc Brake Master Cylinder (Exploded View)

This change consists of a modification to the auxiliary reservoir anchor plate by drilling three (3) holes 3/16" diameter, equally spaced, as shown in the following sketch. This change entered production approximately January 31, 1966. Cars equipped with the drilled anchor plate can be identified by a daub of white paint on the auxiliary reservoir. To help identify the reworked units in the future, it is suggested that you place a white daub of paint on the auxiliary reservoir of each master cylinder that you modify.

- 1. Clean all dirt from master cylinder cover and remove same.
- 2. Using a clean suction gun, remove the brake fluid from the auxiliary reservoir only.
- 3. Remove the auxiliary reservoir attaching screw, anchor plate and reservoir.
- 4. Using the enclosed diagram as a template, lay out and drill three (3) holes, 3/16" in diameter, in the anchor plate.
- Deburr and remove all loose particles before reinstalling plate and master cylinder reservoir.
- Reassemble reservoir, anchor plate and attaching screw. Be sure to align upper reservoir on the master cylinder casting. Tighten retaining screw to 50 inch pounds.
- 7. Refill reservoir with clean brake fluid. Install cover on reservoir and check brakes for proper operation.

DRILL 3 HOLES 3/16" DIA.
EQUALLY SPACED AS SHOWN.
DEBURR AND REMOVE ALL
LOOSE PARTICLES BEFORE
INSTALLING IN MASTER
CYLINDER RESERVOIR.
