SERVICE BULLETIN

No. 66-73

CHOKE COIL BINDING

1966
PLYMOUTH
MODELS
EQUIPPED
WITH
225
CUBIC INCH
ENGINE
AND
HOLLEY
CARBURETORS

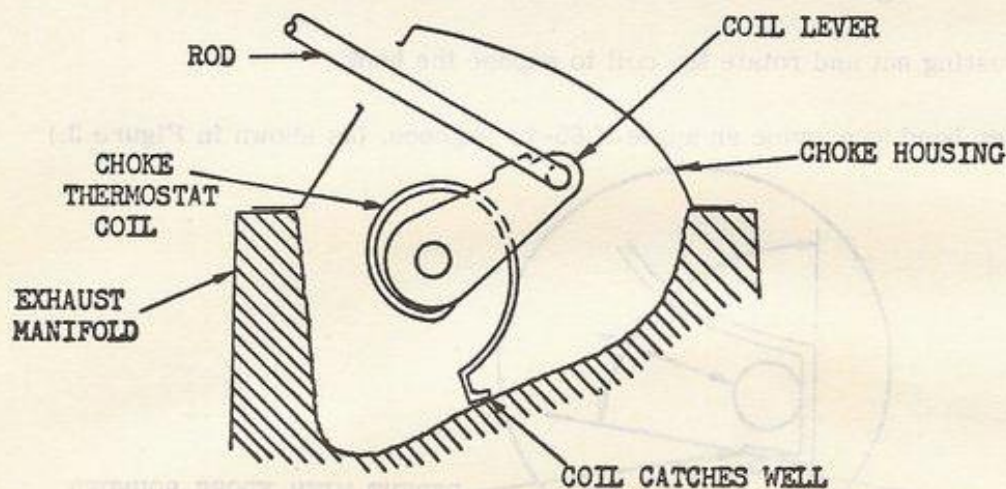
If you experience a starting problem on 1966 Plymouth cars equipped with 225 cubic inch engines and Holley carburetors, it may be due to choke coil to choke well interference as shown in Figure 1. The end of the choke coil catches on rough projections in the cast choke well as it cools down thus preventing the choke from closing. This condition can sometimes be detected by observing bright marks on the bottom of the choke well where the coil has been contacting the surface. If the choke coil is removed while it is caught on the surface of the well a "twang" can be heard as the coil breaks loose while the choke unit is being loosened.

Figure 1. - CHOKE COIL IN STUCK POSITION

A production change is being made to reduce the coil radius so the interference will not occur. Until the new coils are available, Holley are reworking all choke units in their plant by bending the end of the coil to prevent the sharp end from contacting the pocket. The original choke units are identified by 3283 stamped on the cover. Chokes reworked by Holley will carry the number 3283-1. Chokes with the new coils will have 3283-2 on the cover.

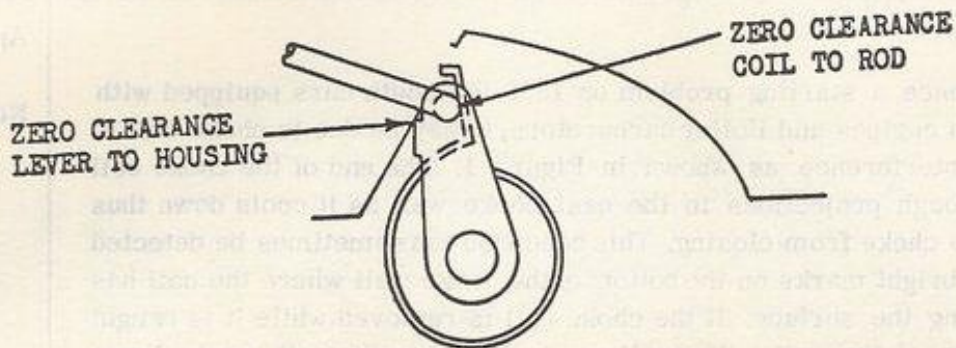
2. The choke coil should then touch the rod when the rod is in its extended position as shown in Figure 2. If such contact does not exist, the coil has been distorted and a new choke assembly part number 2658398 should be used. Rework either the original choke unit if the coil is undistorted or the new 3283 assemblies as described below. (New assemblies with 3283-1 or 3283-2 numbers require no rework).

Figure 2. - UNDISTORTED COIL AT 75° F

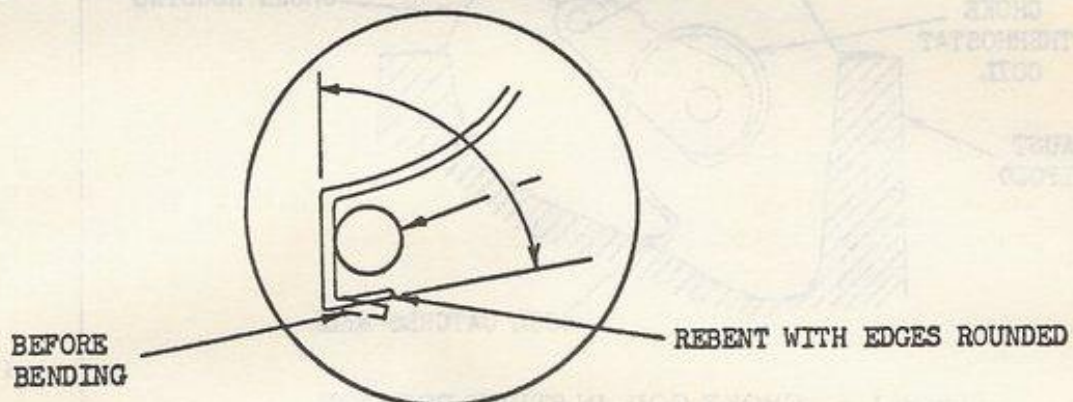
Figure 3. - CHOKE THERMOSTAT HOOK

3. Loosen the adjusting nut and rotate the coil to expose the hook.
4. Change the outer bend to provide an angle of 65-75 degrees. (as shown in Figure 3.)

5. Round the sharp outer hook edges with a file.
6. Return the index disc to the 2 notch rich position. Check to make sure the bottom of the hook contacts the choke rod rather than the bent end.
7. Tighten the locknut.
8. Install the choke, making sure that all of the choke mechanism operates freely.
